## TRACTOR OIL PUMP RELIABILITY IMPROVEMENTS

TEXT AND GRAPHICS BY STEVE "DRIPPY" YOTT

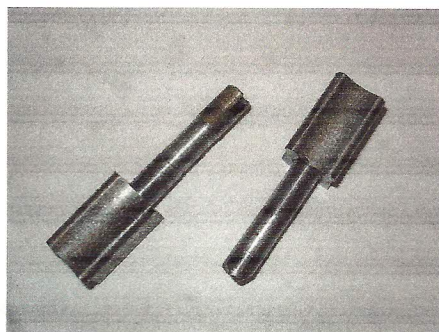
The dimensional tolerances of the internal parts are very tight usually in the .004 to .010 area for the various parts. The main area of concern observed as of late is the wear pattern of the spindle shaft in the pump body. One would think that a steel shaft running in a cast iron pump body would cause wear in the cast iron but further discussions with a few machinists have helped me understand that cast iron contains a lot of carbon which is very abrasive and will cause the steel shaft to wear under most circumstances. In nearly every pump disassembled wear is appearing on the lower bearing surface of the spindle shaft just above the rotor area. I have measured this wear from .005" to .030". In the more extremely worn pumps you can see where the inner rotor has actually worn into the pump end plate because of the tilting of the shaft within the pump body. In the worst catastrophic cases pump failure has occurred because the spindle has bound within the outer rotor and the drive tangs have broken off the spindle.

Photo (#2) shows a typically worn shaft and also a shaft with severed drive tangs caused by this excessive wear.

This is becoming a frequent problem recently and I think we are seeing this because of the poor quality of pump repair kits coming from the parts suppliers. The pump parts in these kits are not hardened and prone to severe wear in 20-30k miles. The racing community has also seen a large number of pump failures which has a very costly outcome! The race community has also seen failures with inner rotor separation

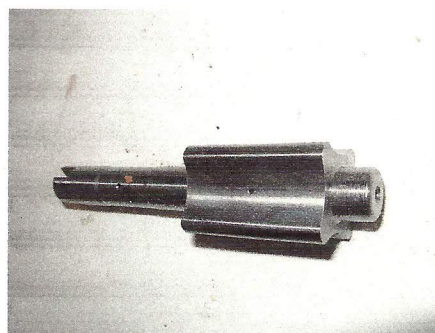
Photo (#3) is of the newly designed one piece spindle/rotor assembly. Notice that this part has a stub shaft on the previously unsupported end of the spindle.

The thinking here is that we are seeing excessive wear at the bearing surface just above the rotor because the internal pressures created in the pump are forcing the spindle to the case sides. This new spindle being supported by three bearing surfaces is a far better design and will not be able to exert sideways pressures as the original. In order to facilitate this new stub shaft the pump body end plate must be centrally located and pinned. It is then surfaced and bored to support the new shaft stub. There is plenty of material in the end plate to support this design. The end plate now being pinned makes it a unique part which is now associated with that pump body only and cannot be mixed as it could have been before. The new spindle/rotor is made in one piece and machined on a

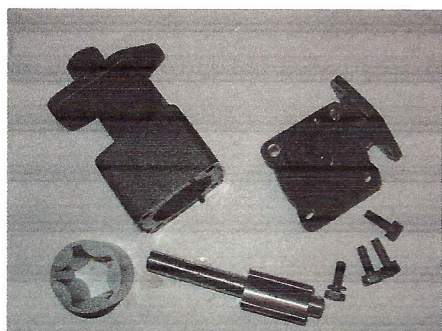
Photo (#4) shows all of the parts of the new design ready for assembly; notice the pins in the pump body and locating holes in the end plate and also the pressure holes in the new spindle assembly.

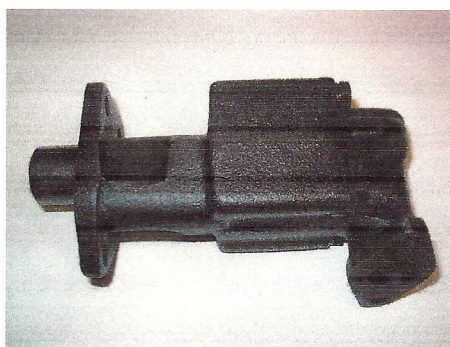
Photo (#5) is of the completed new oil pump.
