## TRACTOR OIL PUMP RELIABILITY IMPROVEMENTS

TEXT AND GRAPHICS BY STEVE "DRIPPY" YOTT

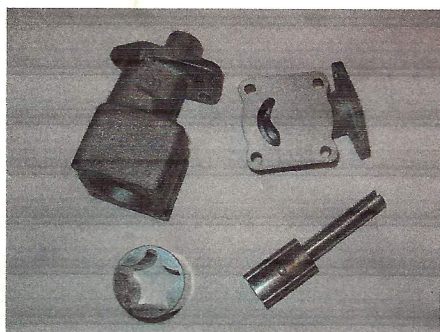
Photo (#1) shows a standard oil pump disassembled as a reference.

The dimensional tolerances of the internal parts are very tight usually in the .004 to .010 area for the various parts. The main area of concern observed as of late is the wear pattern of the spindle shaft in the pump body. One would think that a steel shaft running in a cast iron pump body would cause wear in the cast iron but further discussions with a few machinists have helped me understand that cast iron contains a lot of carbon which is very abrasive and will cause the steel shaft to wear under most circumstances. In nearly every pump disassembled wear is appearing on the lower bearing surface of the spindle shaft just above the rotor area. I have measured this wear from .005" to .030". In the more extremely worn pumps you can see where the inner rotor has actually worn into the pump end plate because of the tilting of the shaft within the pump body. In the worst catastrophic cases pump failure has occurred because the spindle has bound within the outer rotor and the drive tangs have broken off the spindle.
